# ASCC 3-D Laser Scanning Study

## Part 1: Eight participants used scanners to determine target coordinates

by William Paul, James Klinger, and Bruce A. Suprenant

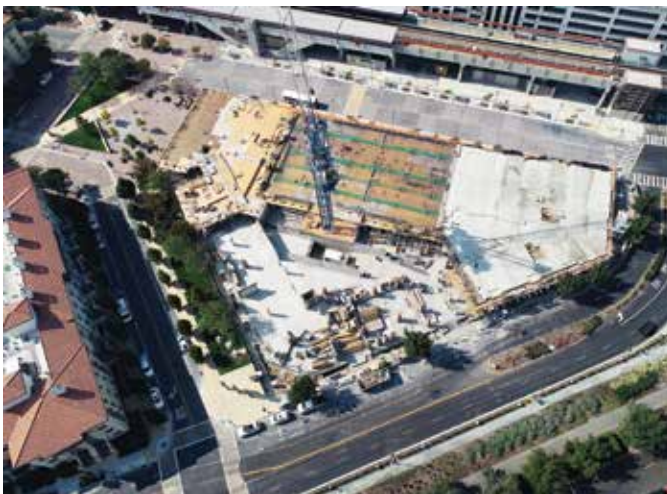
Fig. 1: The project site comprised a ground-level slab (lower left) and a podium level (right) (photo courtesy of BKF Engineers)

The construction project that served as the evaluation site is a hybrid concrete “podium” and wood-framed apartment structure commonly found in California, featuring a basement parking level approximately 10 ft (3.0 m) below grade, a mixed commercial/residential level (ground level), and an elevated residential level approximately 12 ft (3.7 m) above the ground floor (podium level). The podium level was designed to support five floors of wood-framed residential units. The ground and podium levels are post-tensioned elevated slabs supported by cast-in-place columns and shotcrete walls. Test areas at each level were about 6000 ft<sup>2</sup> (about 560 m<sup>2</sup>).

The ground-level test area consists of a nominal 8 in. (203 mm) thick post-tensioned slab with a hard-trowel finish and a limited number of penetrations and conduit stub-ups. The slab was placed on August 28, 2018; the tendons were stressed on August 31, 2018; and the formwork was stripped and the slab reshored on September 3, 2018. At the time of the test, the top surface of the slab had been broom-cleaned. Also, the columns and shotcrete walls for support of the podium level were already in place.

The podium-level test area consists of a nominal 13 in. (330 mm) thick post-tensioned slab with a hard-trowel finish. The test area was part of an overall placement area of 17,000 ft<sup>2</sup> (1580 m<sup>2</sup>) placed on October 5, 2018. The post-tensioning tendons had not been stressed at the time of the test.

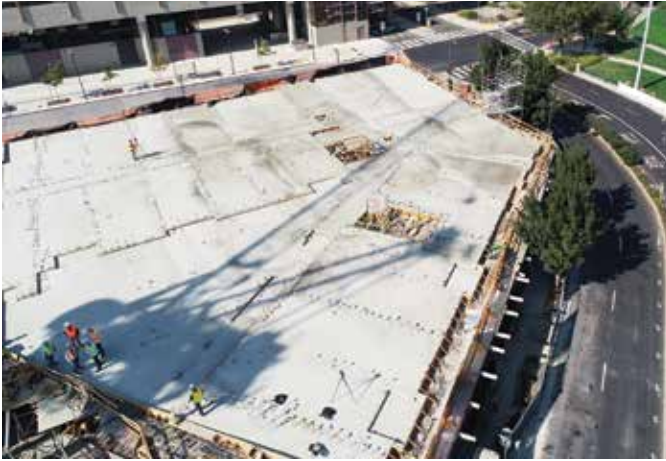
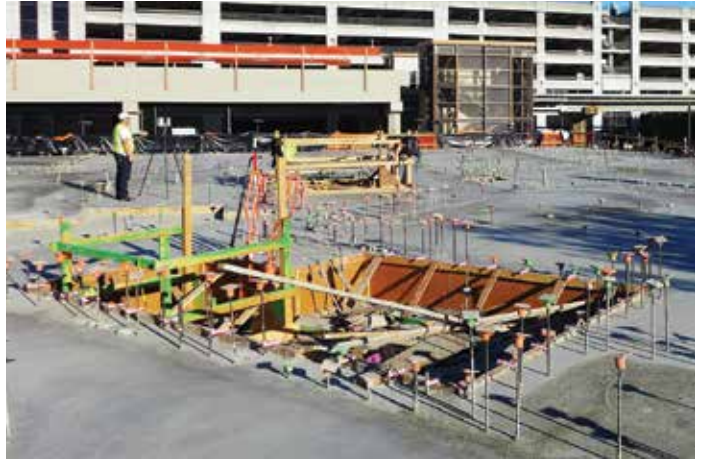
**Fig. 2:** The podium-level slab included many protruding anchor rods (aerial photo courtesy of BKF Engineers)

Because the podium slab is the foundation for the wood-framed structure above, it includes many protruding anchor rods for the framed structure’s shear walls and sill plates. As can be expected in residential construction, the slab also contains many sleeves, conduit stub-ups, and similar discontinuities (Fig. 2).

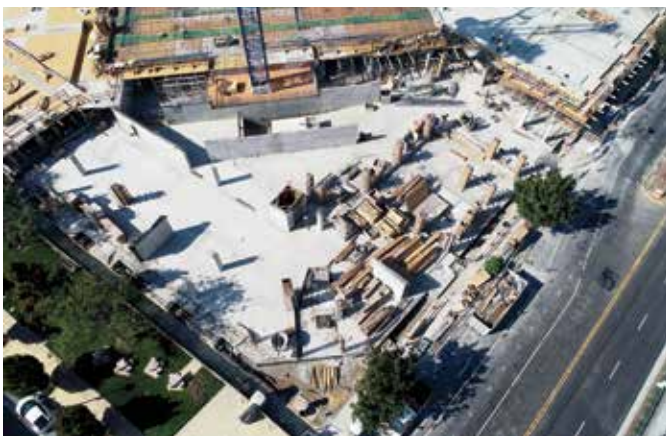
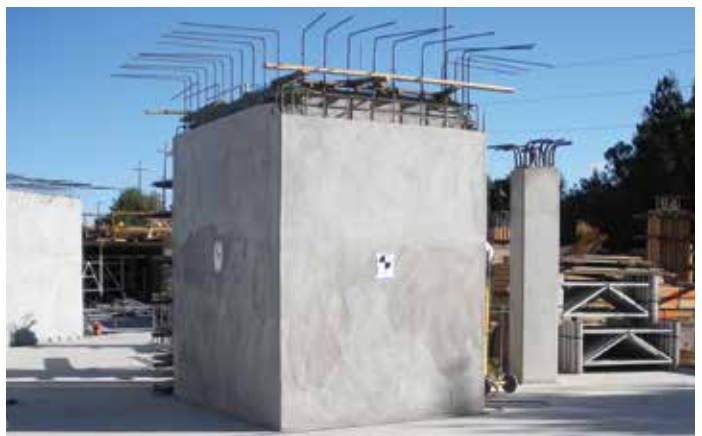
**Fig. 3:** Ten targets were placed at various locations on vertical surfaces (concrete walls and columns at the ground level) for participants to determine their point coordinates. The reference target point coordinates were obtained using a total station at three locations. Ten targets were also placed at various locations on the horizontal concrete surface at the podium level (aerial photo courtesy of BKF Engineers)

Fourteen targets were placed on both the ground- and podium-level slabs. All targets on the podium level were placed on the concrete slab surface. On the ground level, 10 targets were placed on concrete walls (Fig. 3) and columns and four targets were placed on the slab surface. The targets were located such that multiple laser setups would have to be used to obtain a line of sight. This was done to ensure that the participants had to stitch together (register) the individual scans in three dimensions to create a larger, contiguous point cloud. For analysis, all 14 targets were surveyed with a total station from three separate locations to provide the “reference” coordinates. Coordinates for four targets on each level were provided to the participants for control points.

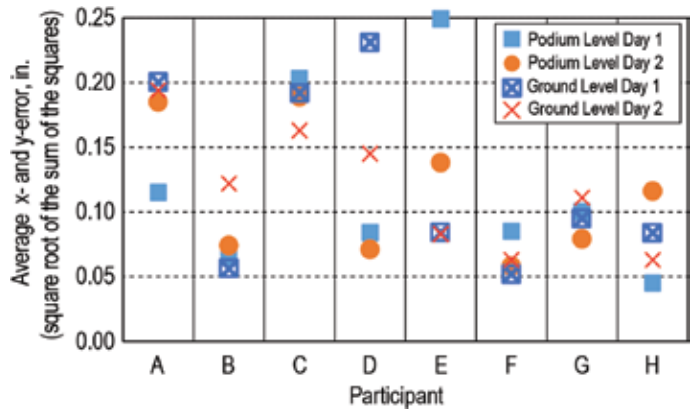
**Fig. 4:** The average SRSS x-y error for each laser participant varied as shown. Participants B, F, G, and H had SRSS x-y errors less than 0.15 in. (4 mm) and good repeatability of the four scans (Note: 1 in. = 25 mm)

Figure 4 shows the average SRSS errors (calculated using x- and y-coordinates) for the 10 targets on both the podium and ground levels for each of the two scans (Days 1 and 2). For all four scans, SRSS error ranges found for Participants C, F, and G were under about 0.05 in. (1.3 mm), while SRSS error ranges found for Participants A, B, and H were under 0.10 in. (2.5 mm). The largest SRSS error ranges were for Participants D and E, with values of about 0.20 in. (5 mm). An SRSS error of 0.20 in. would be an error of 0.14 in. (3.5 mm) in both the x and y directions. Figure 4 also shows that the repeatability of laser scans was very good for most participants. However, the SRSS error range between repeated measurements for Participants D and E was about 0.15 in. (3.5 mm).

As noted previously, the 10 targets at ground level were placed on vertical elements and the 10 targets on the podium level were all placed on the horizontal concrete surface. The SRSS errors and SD values for each level were essentially the same, with average SRSS errors of 0.121 in. (3.1 mm) on the ground level and 0.116 in. (2.9 mm) on the podium level. The corresponding SD values were 0.068 in. (1.7 mm) on the ground level and 0.087 in. (2.2 mm) on the podium level.

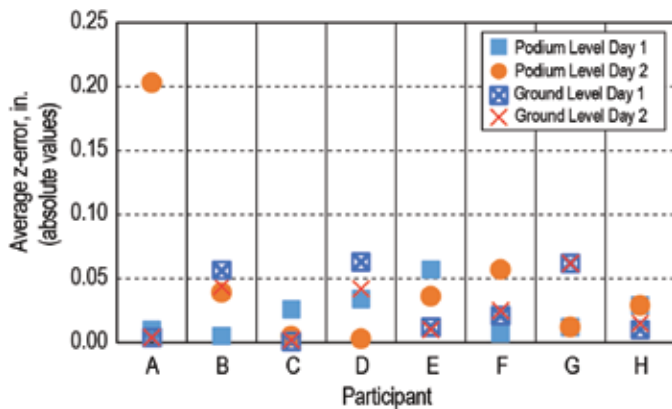
**Fig. 5:** Except for laser participant A, the z-errors were below 0.06 in (1.5 mm) and showed good repeatability for both the ground and podium levels (Note: 1 in. = 25 mm)

Figure 5 shows the average z-error for the 10 targets on the ground and podium levels. The average z-error was very consistent at 0.06 in. (1.5 mm) or below, except for Participant A. Although the maximum z-error for Participant A was 0.20 in., it appears that the high error is an outlier—the other three z-errors found for Participant A were all less than

0.02 in. (0.5 mm). The repeatability between measurements was also very good except for Participant A.

The average z-errors were 0.008 in. (0.2 mm) on the ground level and 0.027 in. (0.7 mm) on the podium level, and the average SDs were 0.086 in. (2.2 mm) on the ground level and 0.048 in. (1.2 mm) on the podium level.
